Martin Luther King Jr. Memorial

ASHEVILLE, NC

SERVICES PERFORMED

Conservation Treatments

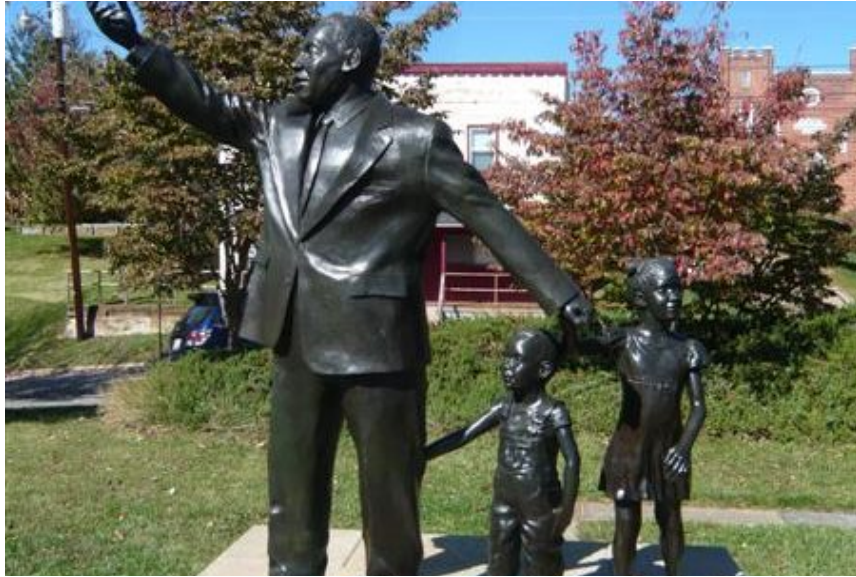
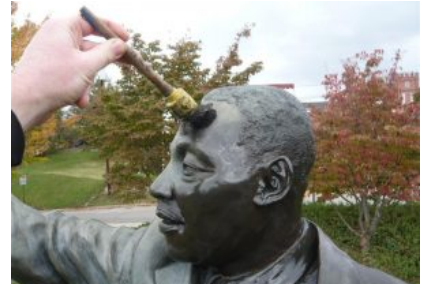
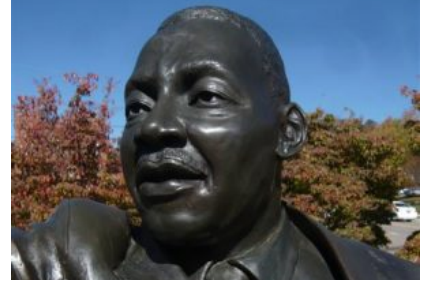
Our conservators worked with the City of Asheville, NC, to provide conservation treatment for the Martin Luther King Jr. Memorial within Martin Luther King Park. The sculpture is a life-sized bronze figure of Martin Luther King holding the hand of a small girl, whilst a small boy holds his pant leg. King's right arm is outstretched in a welcoming gesture to come together. The figures are raised above the ground surface on a cast concrete base.

The existing wax coating was showing signs of deterioration and failure. There were localized areas of light green corrosion that was visible primarily on the feet, heads, and necks, and anywhere water collected. Additionally, bird guano hastened the deterioration of the protective coating in several locations. The old wax coating was removed through a combination of steam and solvent cleaning. The sculpture was cleaned using a gentle detergent and thoroughly rinsed, a detergent with a corrosion inhibitor was applied, allowed to dwell, and rinsed. Areas with corrosion were further cleaned with small detail brushes and nylon pads. Following cleaning, the protective coating was renewed. The sculpture was heated with a propane torch; any existing wax was melted and redistributed. A custom formulated National Park Service (NPS) standard wax with added corrosion inhibitors was applied using natural bristle brushes applied to heated surfaces. After the sculpture cooled, an additional coating of cold paste wax was applied, allowed to dry, and thoroughly buffed with cactus hair buffing wheels and polishing hand brushes.
