Iwo Jima Monument

MARINE CORPS RECRUIT DEPOT, PARIS ISLAND, SC

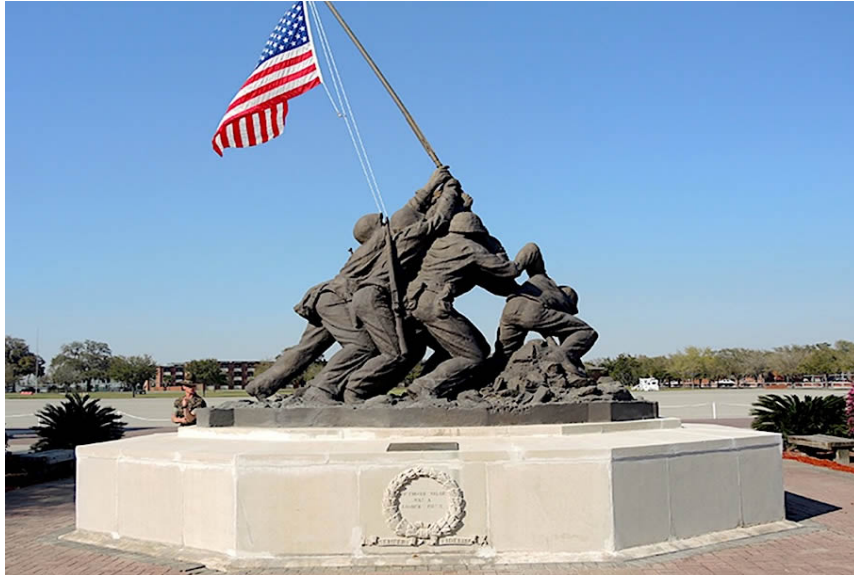
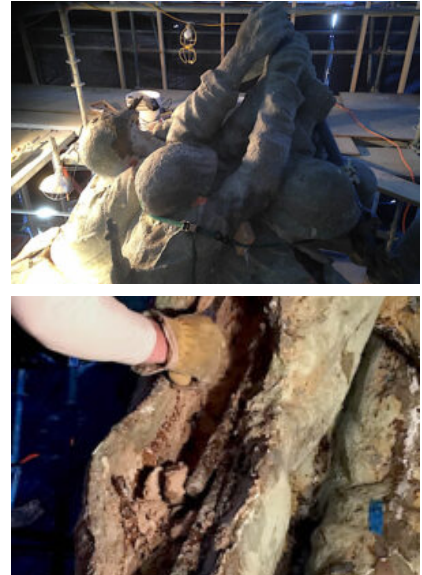
The goals were to reverse deterioration of the sculpture caused by severe cracking of the concrete from corrosion of internal rebar due to continuous ingress of water, dissolution of the clay core, and the application of impermeable and inflexible coatings preventing the escape of moisture from the saturated construction. Work entailed removal of all coatings and previous repairs, partial disassembly of the sculpture sections, excavation of saturated and failed core material, corrosion mitigation and replacement of failed rebar, application of a corrosion inhibitor, reconstruction of the original concrete sections, crack and surface repair, repair of the flagpole, and an application of a new coating system appropriate for concrete. All stages were thoroughly documented and maintenance recommendations were provided to the client.

We were subcontracted by Terra Mare Conservation, LLC (TMC) as part of a highly experienced, interdisciplinary team gathered to conserve the Iwo Jima Monument, located on the parade deck at the Marine Corps Recruit Depot. The treatment was based on the assessment our firm performed in understanding the causes of the deteriorating concrete sculpture of the iconic group.
